PRIMARY HEALTH CARE CENTERS
NUMBERED KE-01, KE-02,
KE-03, KE-04, AND KE-05
KIRKUK, IRAQ

SIGIR PA-06-042
SIGIR PA-06-043
SIGIR PA-06-044
SIGIR PA-06-045
SIGIR PA-06-046

APRIL 25, 2006

SUBJECT: Report on Project Assessments of Primary Health Care Centers Numbered
KE-01, KE-02, KE-03, KE-04, and KE-05 in Kirkuk, Iraq (Report Numbers
SIGIR-PA-06-042, PA-06-043, PA-06-044, PA-06-045, and PA-06-046)

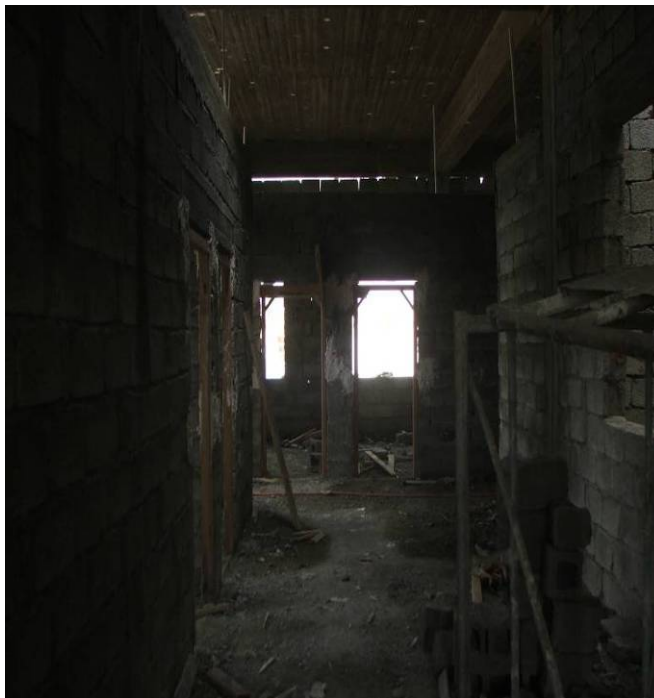
At the time of the assessment, we observed the partial installation of some wooden interior doorframes (Site Photo 59); however, we did not assess the doorframes due to time restrictions on site. We identified additional wooden doorframes on site (Site Photo 60). We did not observe any exterior doors, windows, or hardware on site.

Site Photo 59. Doorframes partially completed

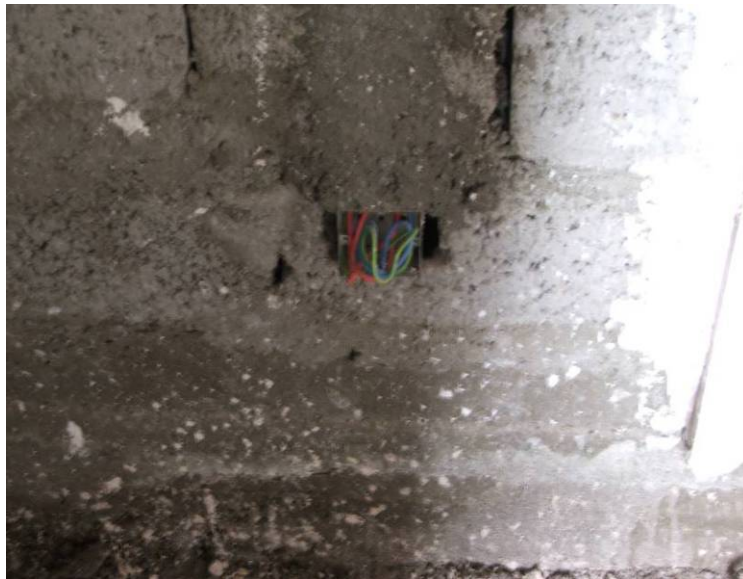
The SORS required all electrical design and construction to comply with IECS. The SORS required new energy efficient lighting, switched power outlets, and lighting switches. Electrical power and lighting requirements included interior and exterior lighting, surgical lighting, commercial grade wiring, panels, breakers, switches, outlets, junction boxes, transformers, connectors, and fixtures. Additional submittal requirements included, switchgear, electric heaters, sump pumps, lightning protection, radio paging, emergency lighting, fire alarm system, central control and maintenance system, and the circuit protection. SORS also required a safe and sufficient power connection to the local grid and critical, standby and primary power generators. At the time of the assessment, the electrical system installation was underway. We observed basic electrical preparatory work. The electrical work observed consisted of the installation of PVC conduit and plastic or metal electrical boxes attached to the surface of the block walls or recessed in a chiseled section of the wall. We observed wiring installed inside the PVC conduit in some areas (Site Photo 67) and some outlet boxes with wiring (Site Photo 68).

Site Photo 68. Wires within outlet box

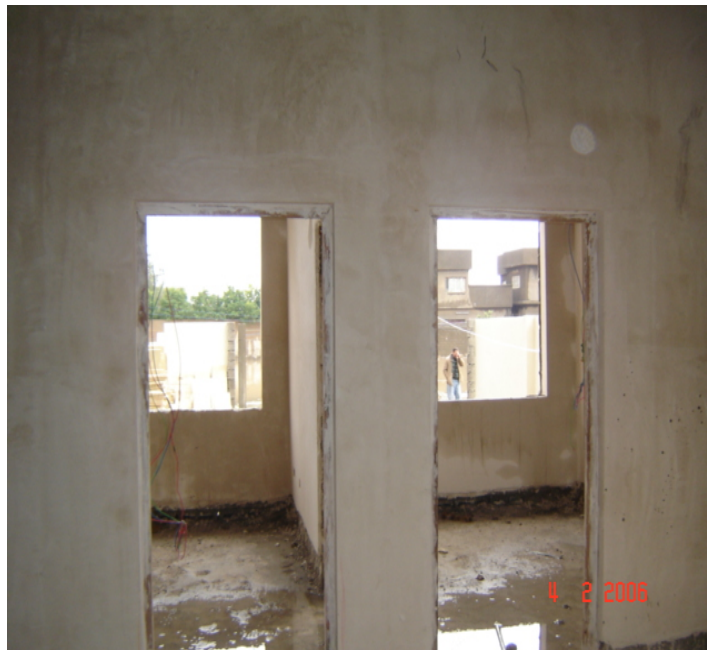
At the time of the assessment, we observed the installation of some wooden interior doorframes (Site Photo 73); however, we did not assess the doorframes due to time restrictions on site. We did not observe the installation of exterior doors nor did they appear to be on site. The contractor had not installed any windows or security grilles (Site Photo 74). Interior walls were not painted and the fabrication of the suspended ceiling had not started. We did not observe any doors, windows or hardware on site.

Site Photo 73. View of completed doorframes (Photo courtesy of the USACE)
